EPA/OEPA SITE VISITS
OHIO VALLEY COAL (TOVCC)
and
AMERICAN ENERGY (AEC)

October 25, 26 and 27 2011

December 16, 2011

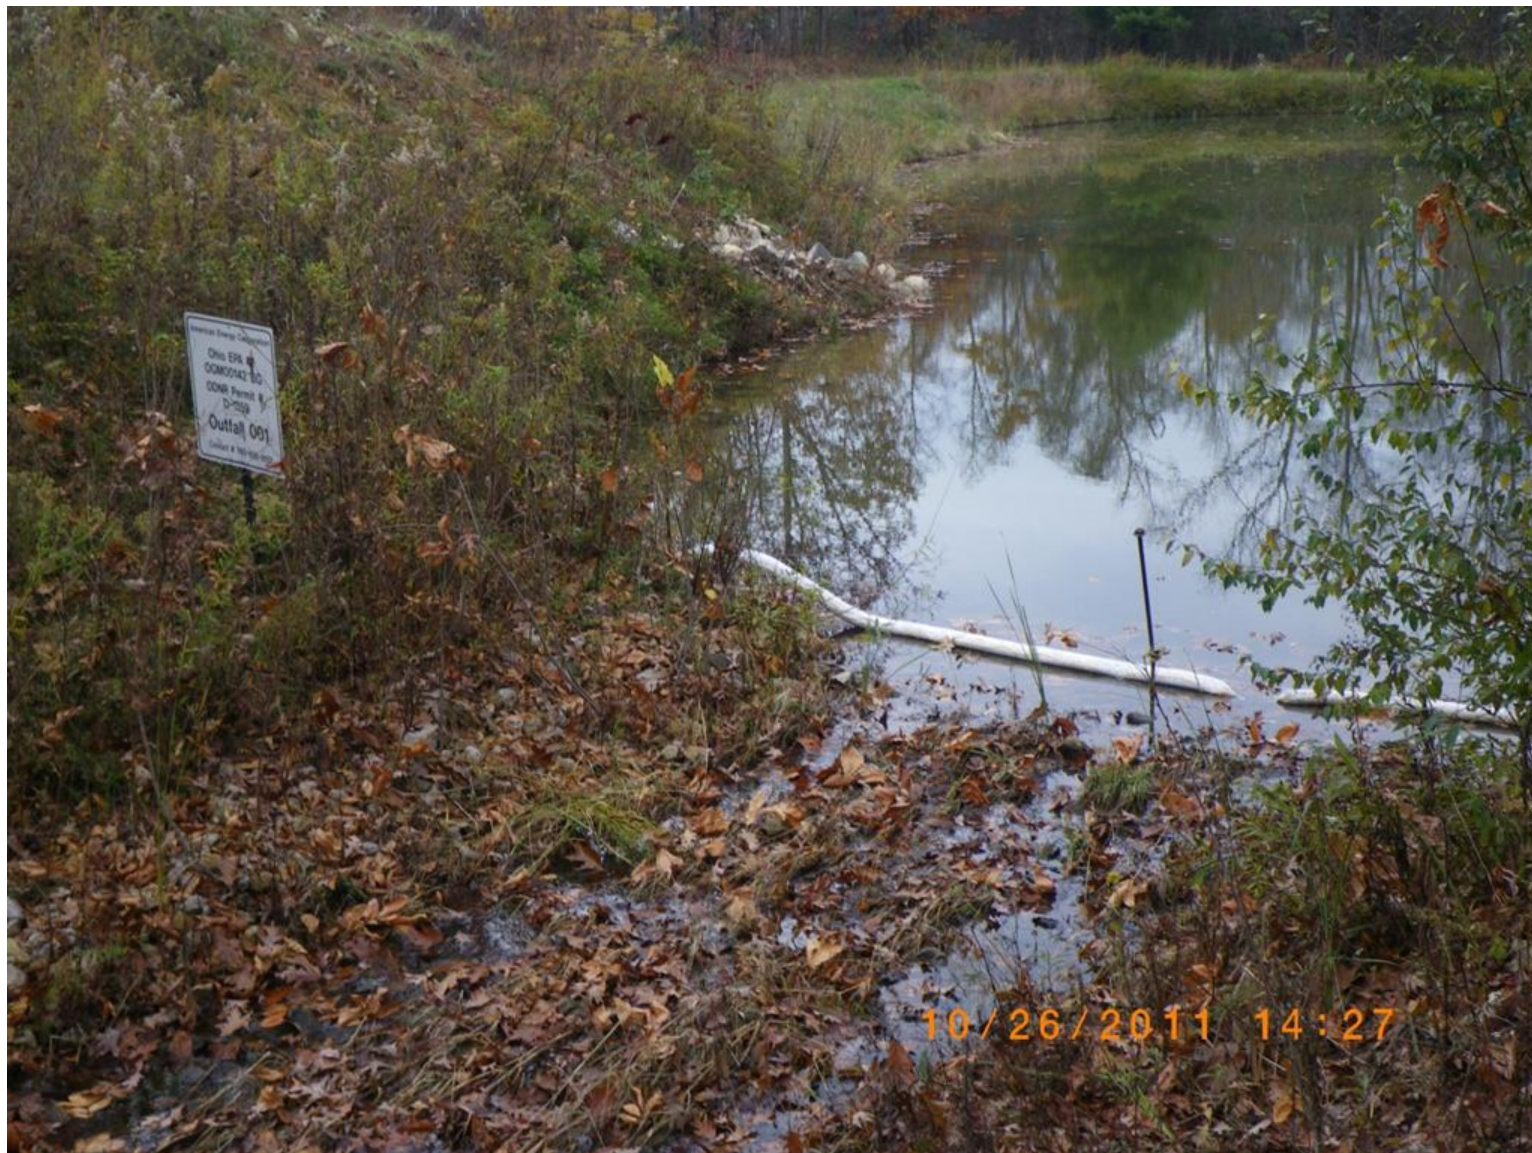
Pond 1 strip mine AEC

Strip mine Pond 1 Outfall – not clear of discharge/sampling location.

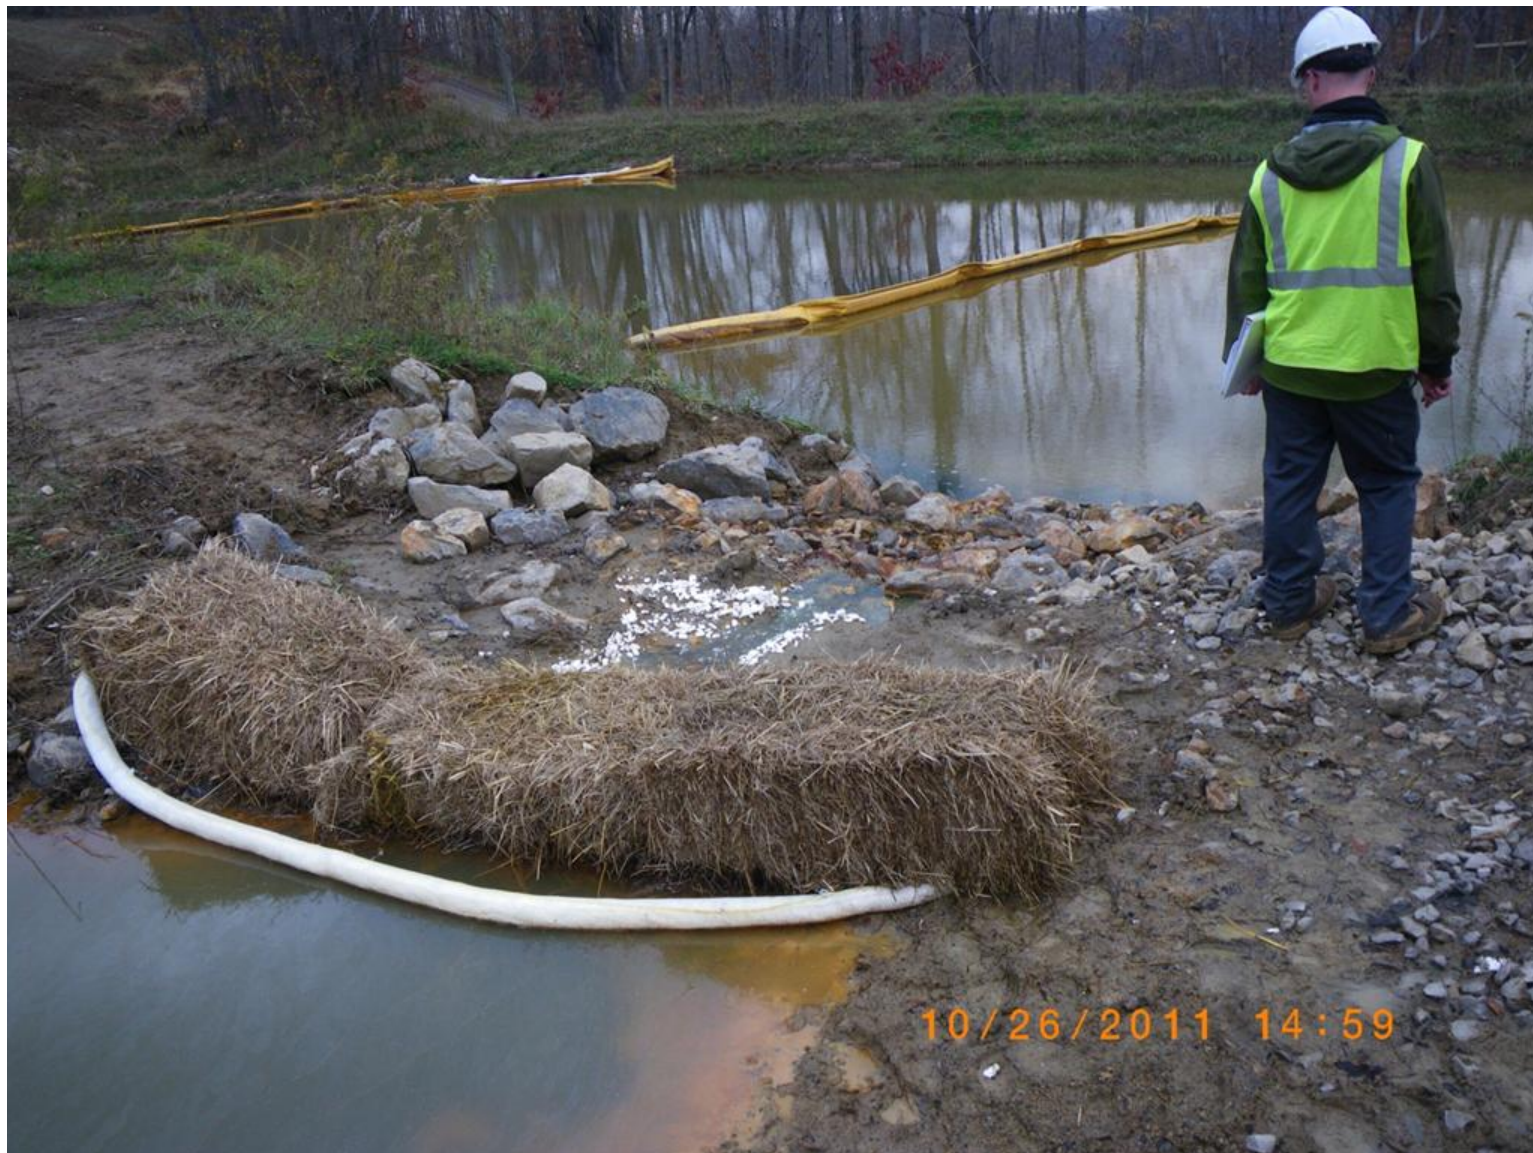
AEC Pond 15 – outlet from pretreatment sump to pond – rip rap should be replaced- better erosion control would aid in pond performance.

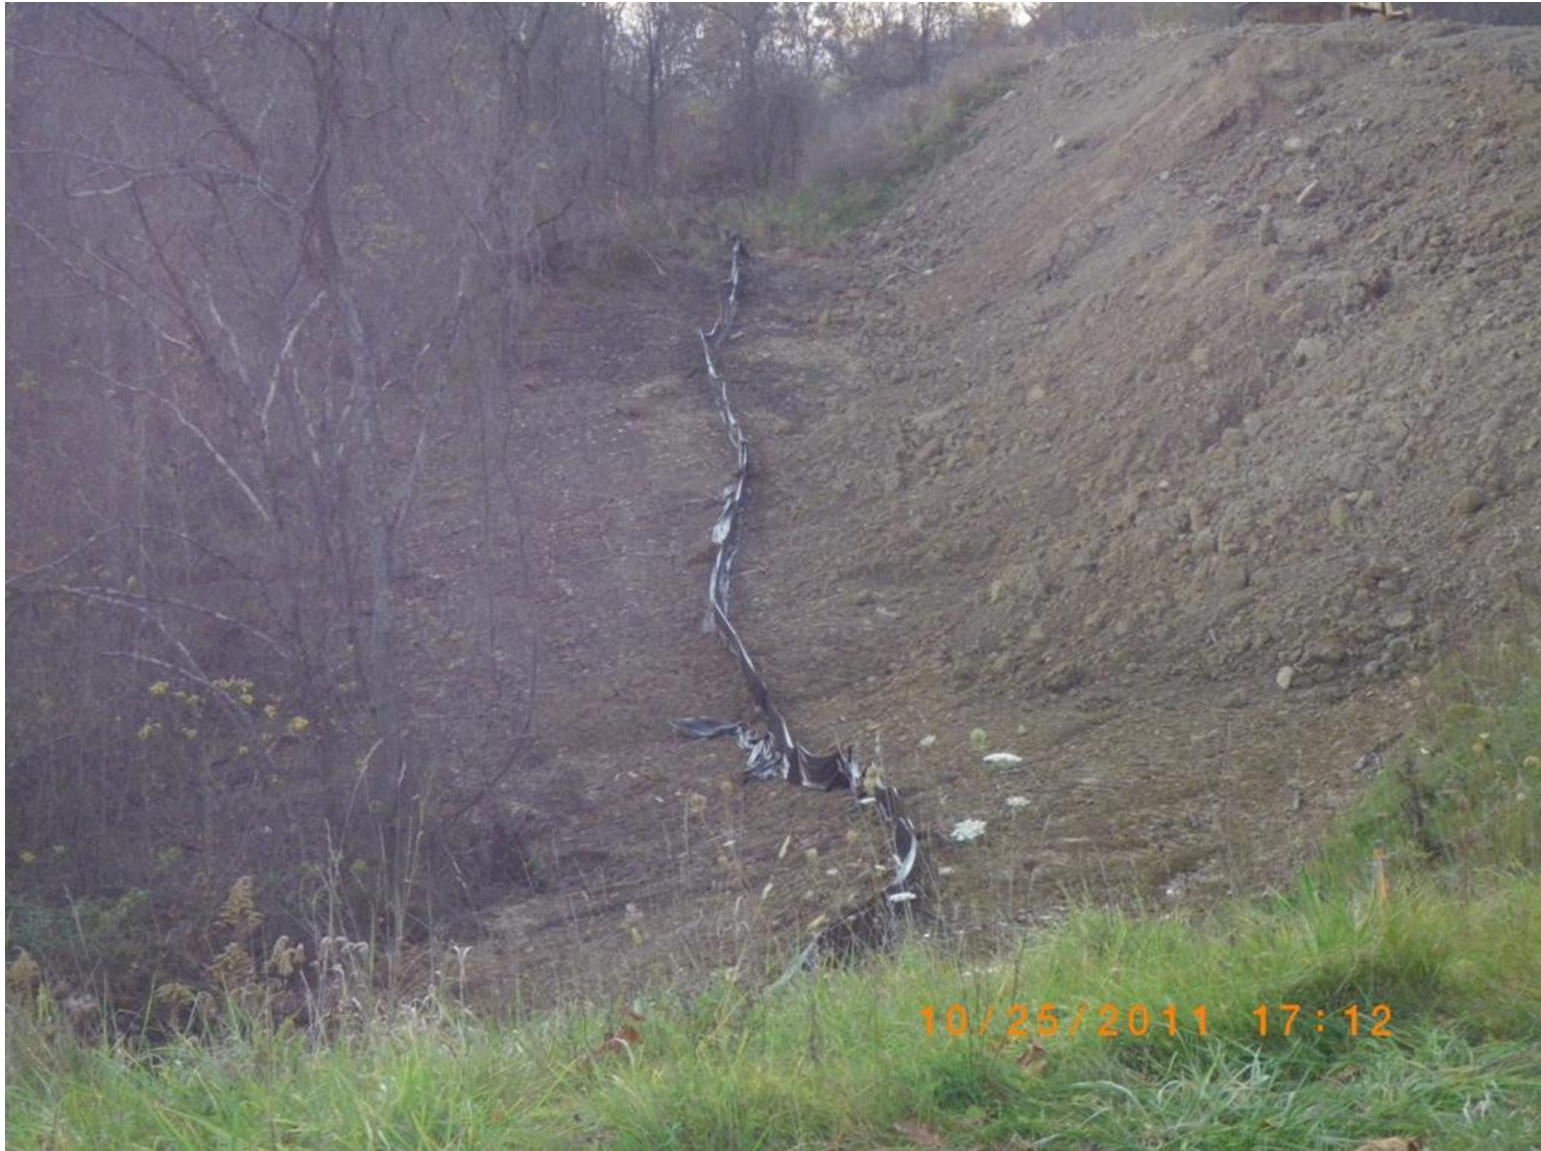
Active mining area
near AEC Ponds 13 and 14-runoff
not captured by ponds

Active Mining area west of AEC Pond 14 – run-off from this area not captured by ponds.

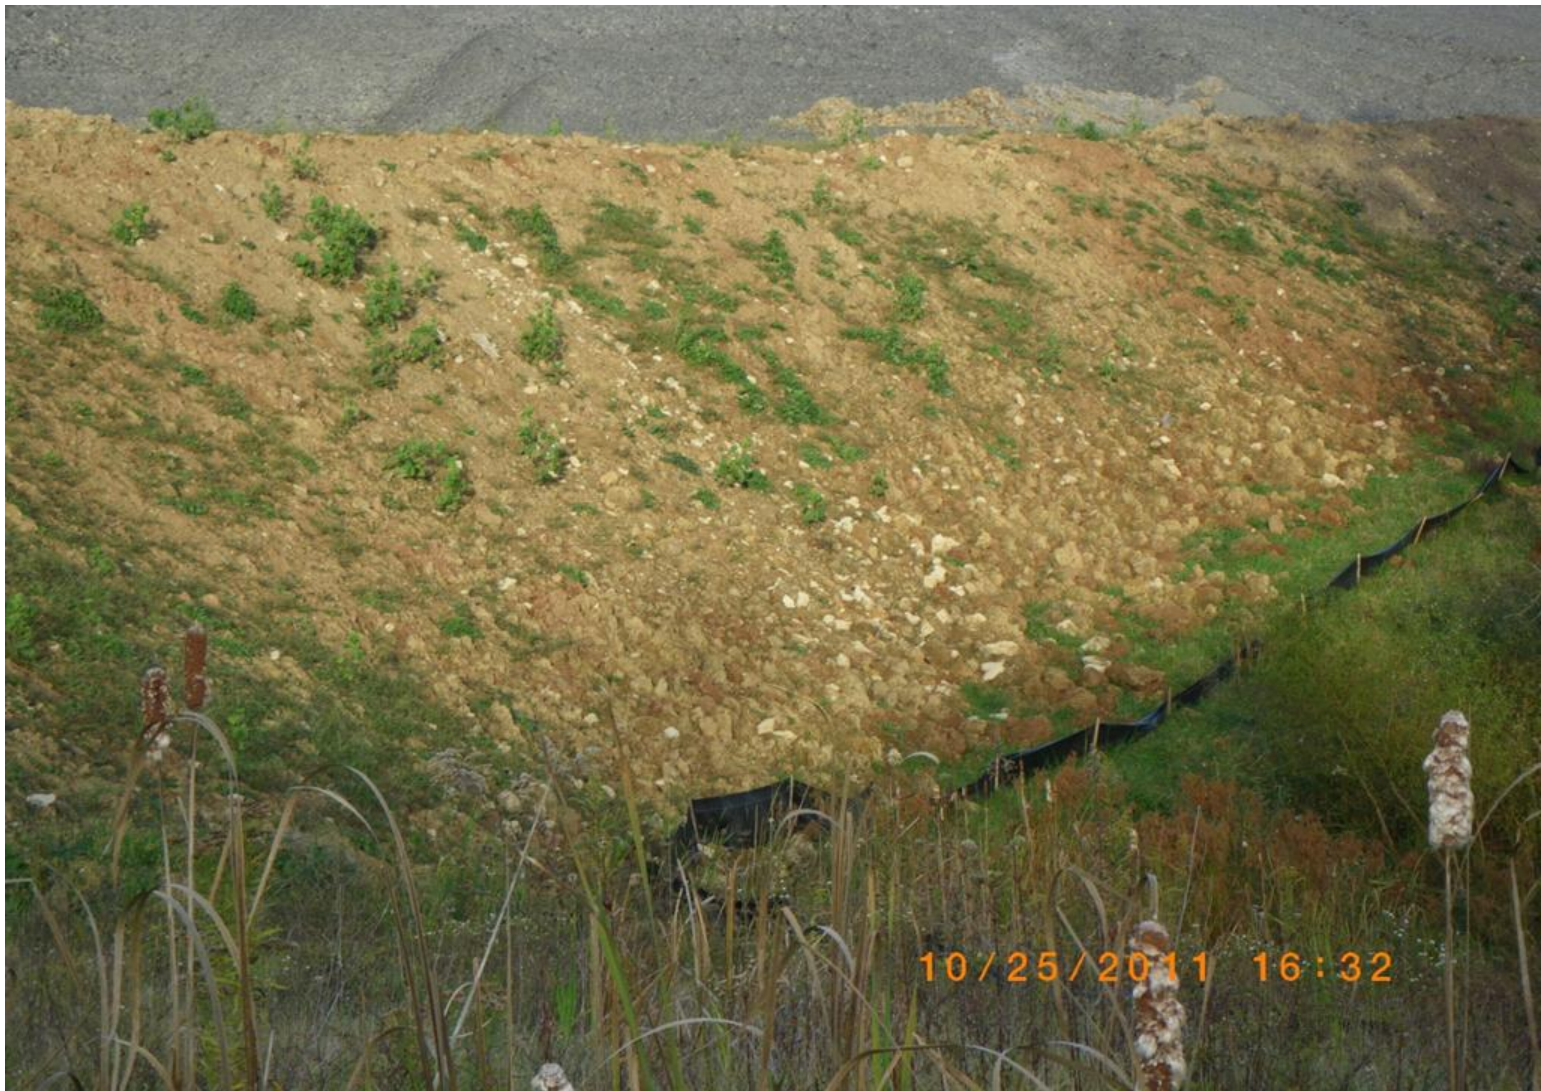
Active mining area between Pond AEC 14 and AEC 13 –
Berm sloped to unnamed tributary to Piney Creek – run-off not captured by ponds.
